**Preliminary Survey of Waste Materials  
Deposited at the Proposed Park Site,  
Hamilton Harbour, November 1984.**

**Air Resources Branch  
Phytotoxicology Section**

**Date: March, 1985**

**ARB No.: ARB-050-85-PHYTO**

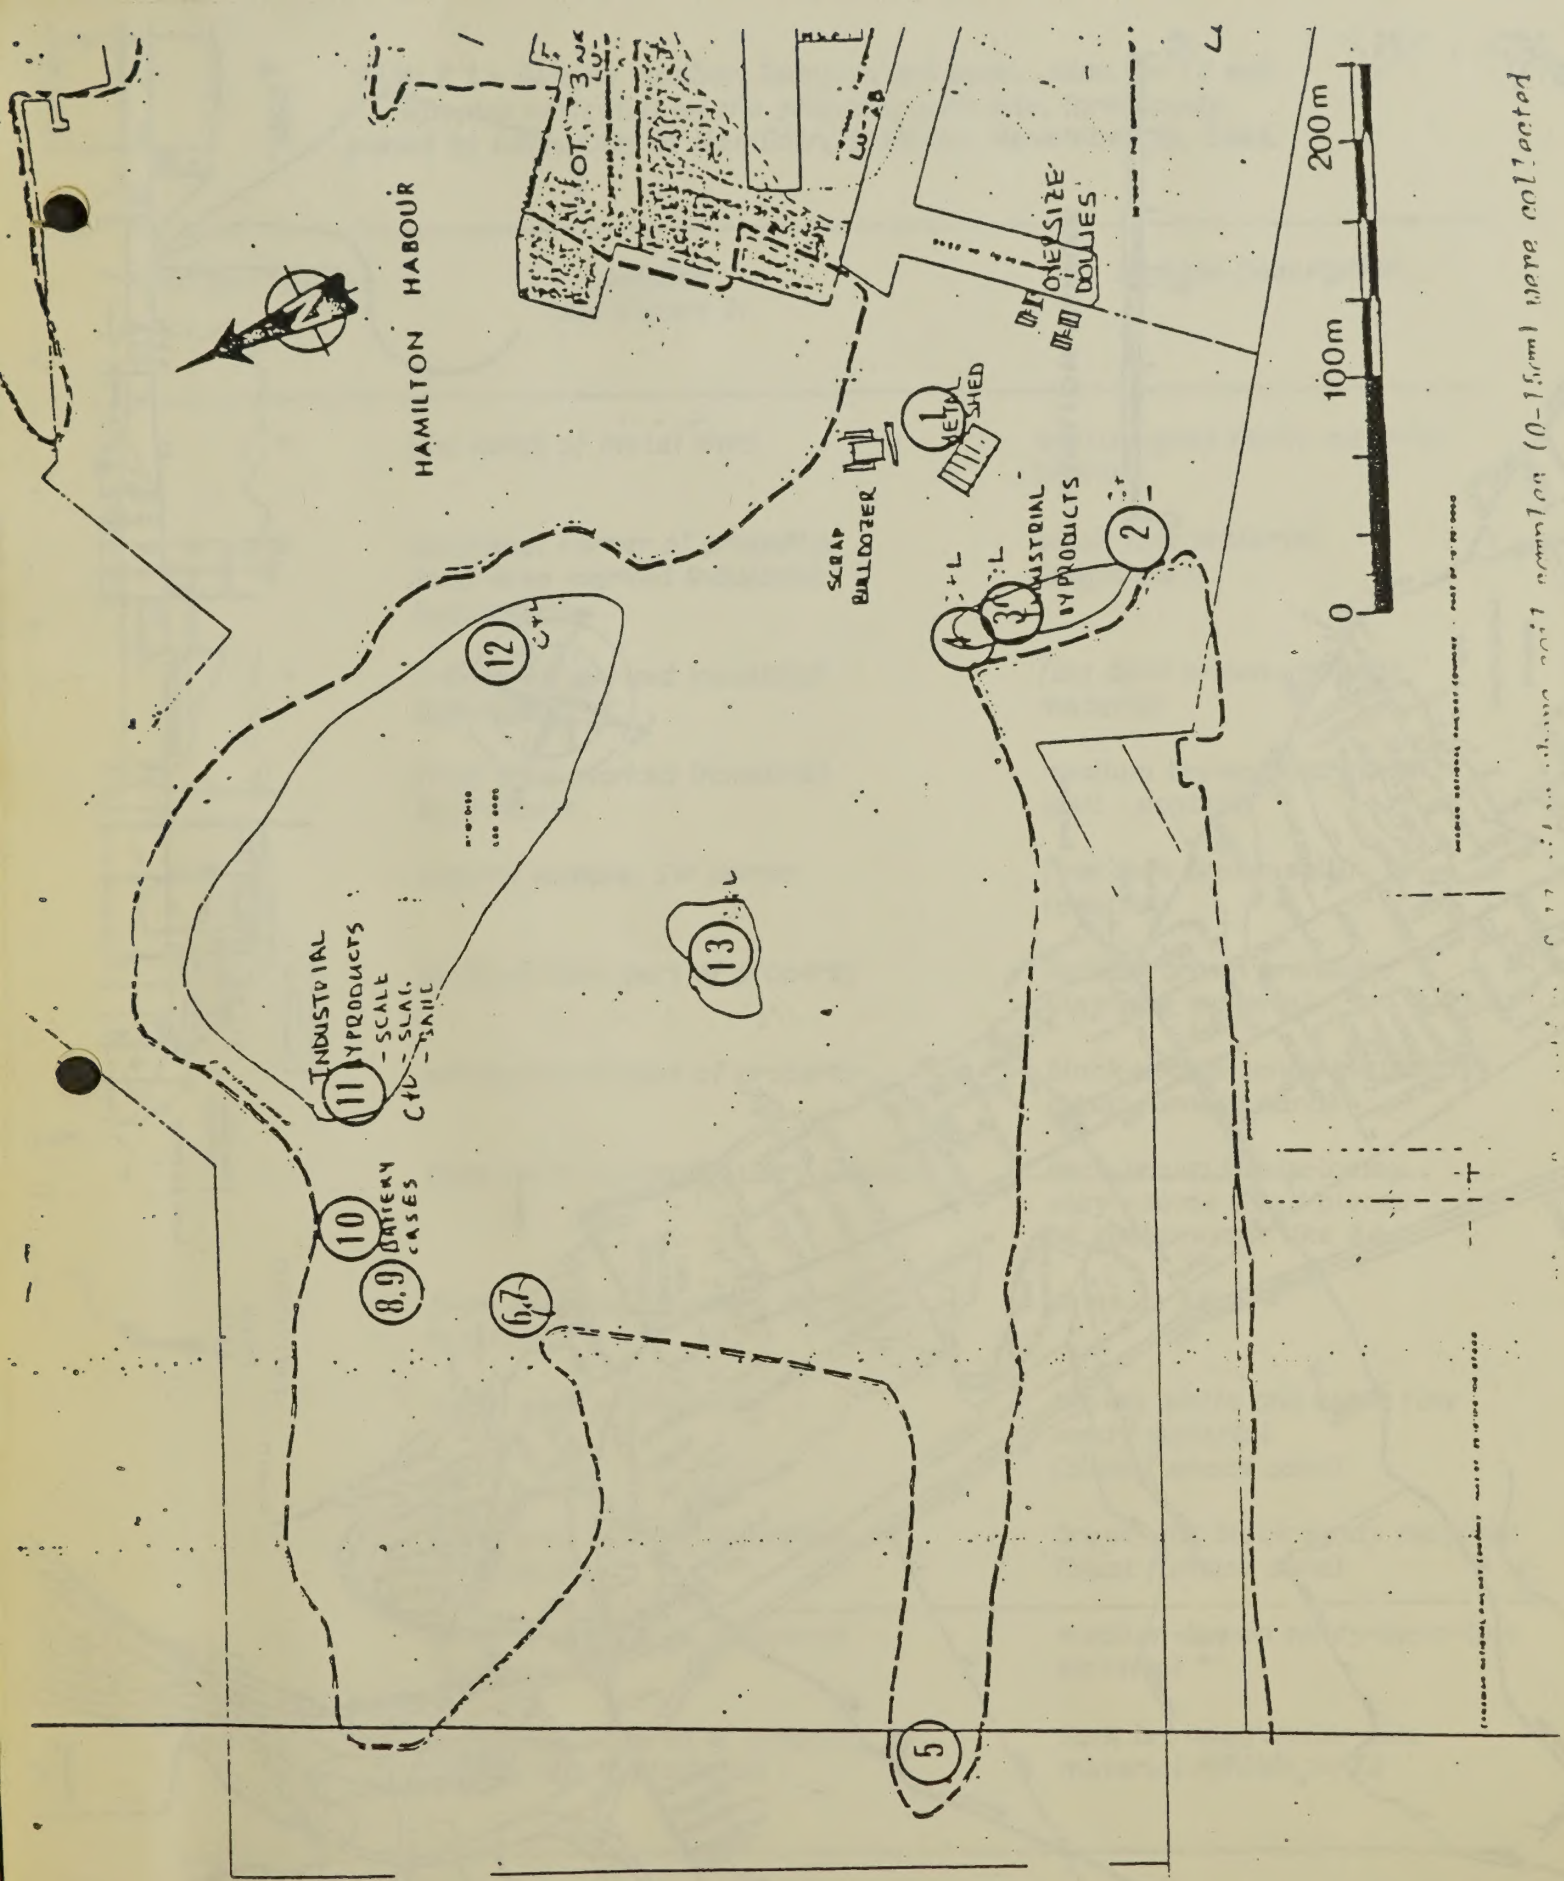
On November 29, 1984, 13 stations were sampled at the proposed park site (former Lax property), Hamilton (Figures 1 & 2). The stations were selected using a map provided by the regional office (Figure 1) and during a reconnaissance of the area. With the exception of sites 4 and 5, with site 5 being a control location in the park, the sampling sites were devoid of vegetation. A description of the samples collected (0-15 cm depth) appears in Table 1. No visual assessment of possible phytotoxic effects was made due to the lateness in the season.
